A GLOBAL CP PROBLEM

Ted Huck, Matcor, USA, discusses attenuation deficit disorder and pipeline rehabilitation.

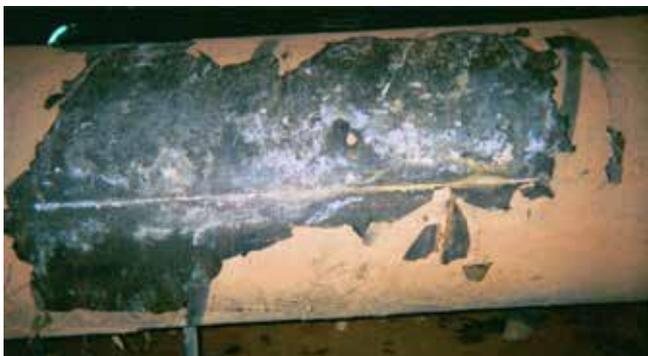
Figure 1. Asphaltic enamel coating failure.

Pipeline operators worldwide are grappling with what to do as their 1950s once state-of-the-art coatings systems start to fail. With millions of kilometres of CTE type coated pipelines installed worldwide, this is an ever-increasing problem. A variety of factors can affect the service life of these coatings and, in many cases, pipelines that were installed over 50 years ago continue to find their CTE type coatings in good shape. However, these coatings are at, or past, their expected service life and failures are inevitable. When CTE coating ages and starts to fail, it generally does so in a non-shielding mode, with large chunks of the coating dissociating with the underlying steel pipeline.

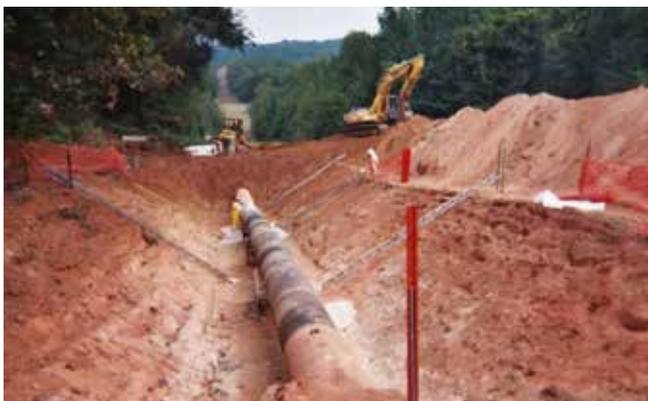
Figure 2. Recoating operation along the open right-of-way (ROW).

Replacing the coating system, or recoating, is an invasive process that requires the pipeline to be fully excavated along the entire length so that a new coating can be field applied. The access issues can be significant and invariably there will be areas that are just not easily excavated, and will likely have to be skipped and addressed separately.

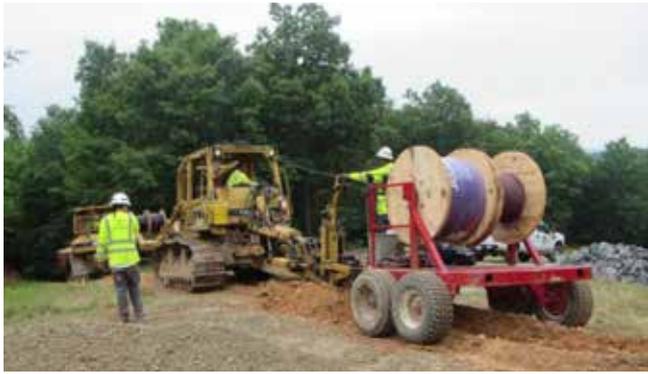
Figure 3. Cable plow installation of linear anode to the side of the pipeline along the ROW.

The advantages of the linear anode rehabilitation approach are that it is a much less intrusive installation and does not require the pipeline to be fully exposed along its entire length. The linear anode can be installed using a variety of methods including cable plow, backhoe/trenching and – in congested areas where soil disturbances need to be avoided – the linear anode can be installed using horizontal directional drilling (HDD). The cost of linear anode installation is significantly less than the cost of recoating a pipeline – with typical costs being no more than 20% of the cost of recoating (and in some cases much less) and the installation takes a fraction of the time of a recoat project.
